District 2 – Coal Mine Near Miss

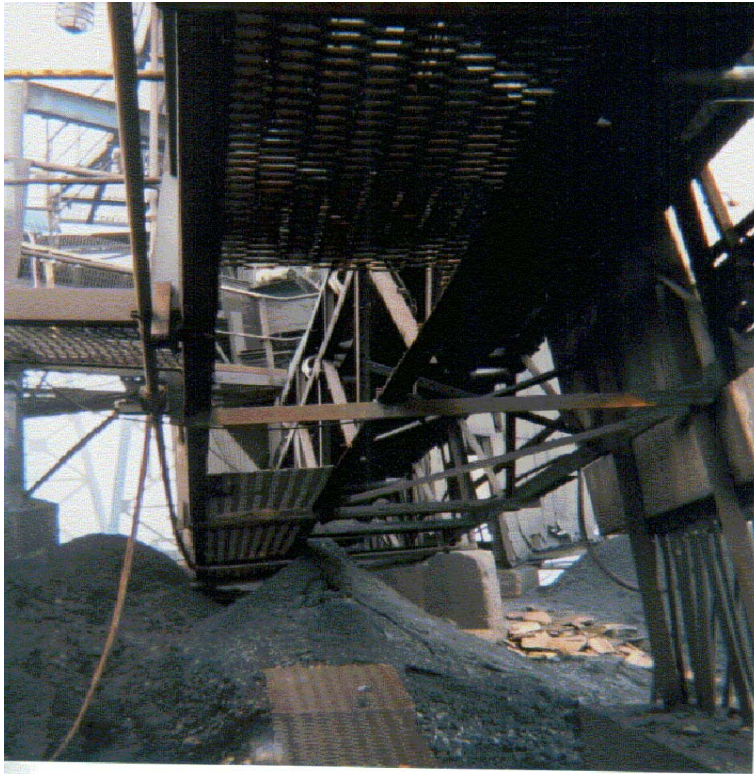
On Monday, August 2, 2004, a preparation plant utility man began his shift at 6:00 am. At approximately 6:15 am the sizing screen, located outside the plant, plugged up. The utility man exited the plant and was traveling down along the #1 plant feed belt when he fell approximately nine feet through an eight foot long by two foot wide opening in the travel way. This section of walkway was removed on July 29, 2004, and was to be replaced at that time. However a break down in the plant resulted in the repairmen being sent to the plant before the section of walkway could be replaced. The area was not guarded to prevent persons from falling through the hole. The utility man received a fractured vertebra as the result of the fall.

- Protect accessible openings with substantial railings or barriers to prevent falls of persons.
- Establish procedures and train personnel in those procedures for removing, protecting, and replacing decking during construction or maintenance.
